Site 46 Proposed IMPs

**UPPER PATUXENT RIVER WATERSHED RESTORATION ACTION STRATEGY (WRAS)
FORM 1 -- Catchment Information**

**UPPER PATUXENT RIVER WATERSHED RESTORATION ACTION STRATEGY (WRAS)
FORM 2 -- Site Information**

Site Name: _____ Address: 2126 Espey Court

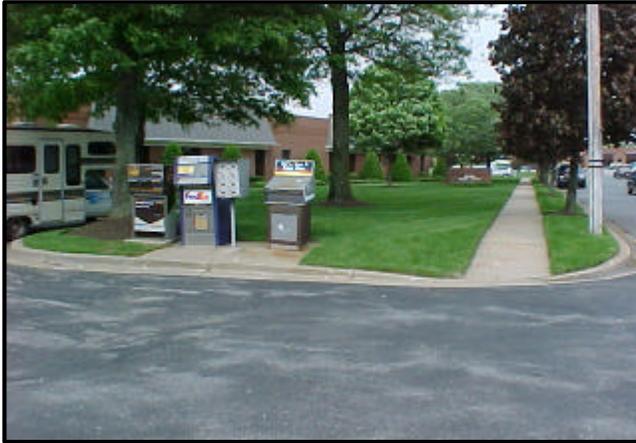
806

No. <u>806</u>	Description: <u>looking east along south side of site</u>
No. <u>807</u>	Description: <u>looking north along west side of site</u>
No. <u>808</u>	Description: <u>looking east along north side of site</u>
No. <u>809</u>	Description: <u>looking south along west side of site</u>
No. <u>810</u>	Description: <u>looking west along north side of site</u>
No. <u>811</u>	Description: <u>looking south along east side of site</u>
No. <u>812</u>	Description: <u>looking west along south of side of site</u>
No. <u>813</u>	Description: <u>looking north along east side of site</u>
No. <u>814</u>	Description: <u>downspout</u>
No. _____	Description: _____

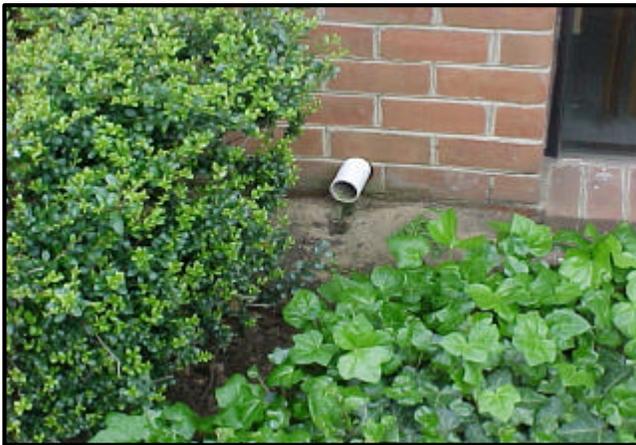
814

Comments North portion of the property drains offsite (site 37). South portion of the property drains offsite (site 45). Property collects flow from offsite (sites 37 & 45). Roof downspouts that drain a small portion of the metal roof drains onto impervious surface landscaping.
